JOHNSON COUNTY DAM A-26

JOHNSON COUNTY, MISSOURI

MO 20073

PHASE 1 INSPECTION REPORT NATIONAL DAM SAFETY PROGRAM

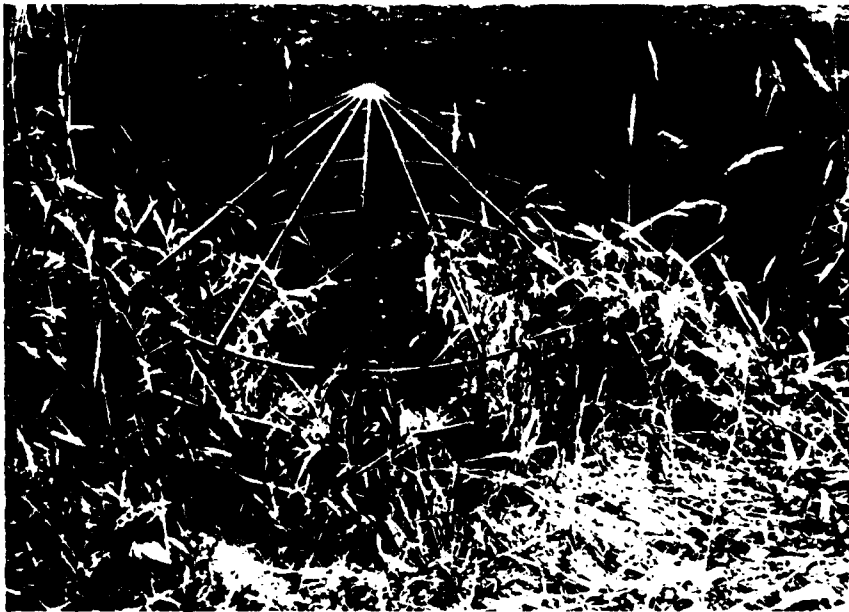
PHOTO 7: PRINCIPAL SPILLWAY DROP INLET
